PA-467 DAM

SUSQUEHANNA COUNTY COMMISSIONERS

PHASE I INSPECTION REPORT

NATIONAL DAM INSPECTION PROGRAM

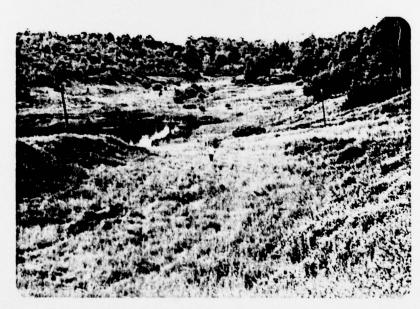
D. Auxiliary Spillway Approach Channel

The auxiliary spillway was in good condition (Photographs A, D, and E) except for minor amounts of brush. The previously mentioned communications line spans the spillway approach channel (Photograph D). At its lowest point, the line was at the same elevation as the top of the dam. The embankment extension (dike) downstream from the dam along the right side of the auxiliary spillway outlet channel was in good condition (Photographs E and F). The dike was partially riprapped, and the remaining portions were covered with crownvetch.

(1) Remove brush from the downstream slope of the embankment and from the auxiliary spillway.

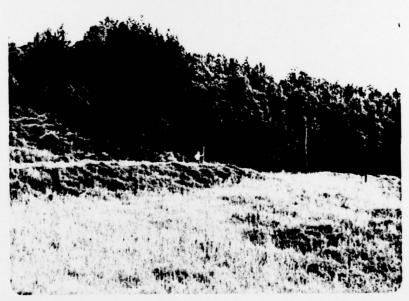
F. Embankment Extension Along Right Side of Auxiliary Spillway Exit Channel
